HENLOCK LAKE DAM

NDI-PA 00399
PA DER 52-71

PHASE I INSPECTION REPORT NATIONAL DAM INSPECTION PROGRAM

MAY 1979

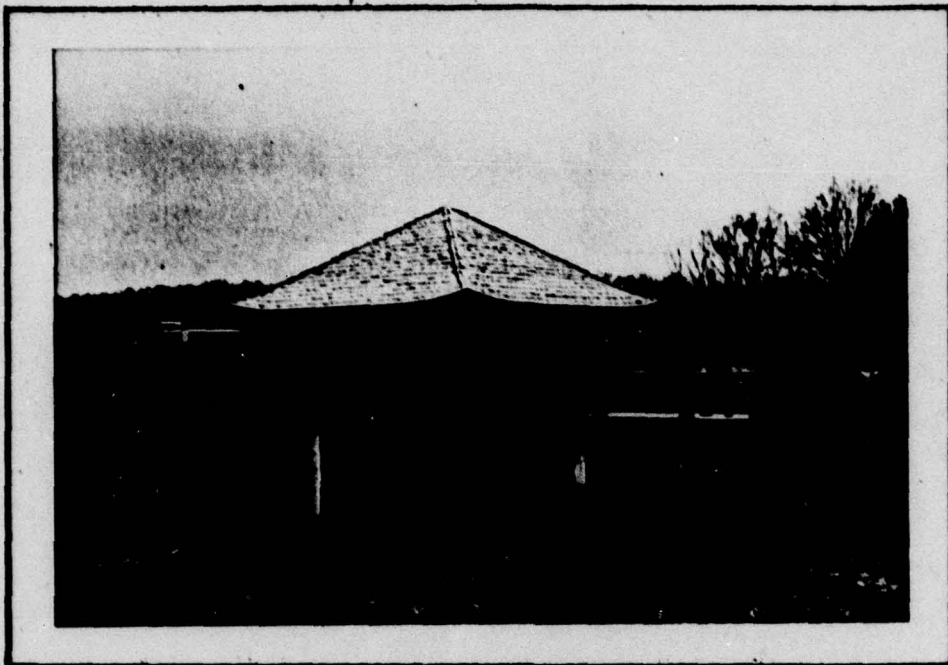
- c. Appurtenant Structures. The gate house is evidently well maintained. The Owner's representative reported that the reservoir drain gate valve is functional, but he was unable to operate it during the inspection because he did not have the gate valve hoist wheel.

*PAGODA SHELTER BUILT ON TOP OF
RESERVOIR DRAIN GATE VALVE TOWER*

The Owner's representative reported that the reservoir drain gate valve works, but he did not have the gate valve hoist wheel during the field investigation. It is recommended that the Owner assess the functional condition of the reservoir drain gate valve and exercise the valve periodically.

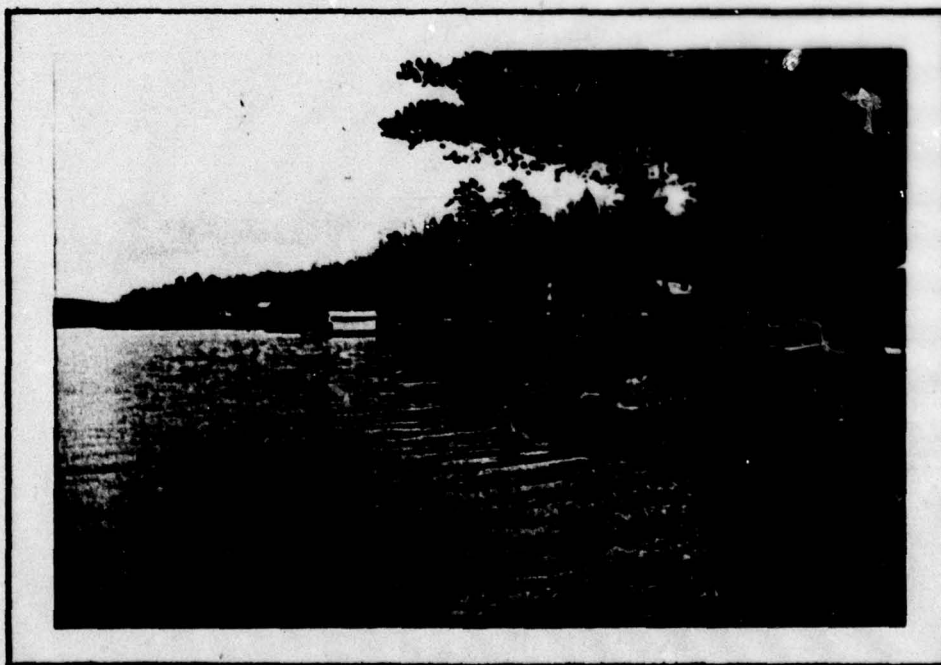
- e. Downstream Channel. Lower Lake is located immediately downstream of Hemlock Lake, and has a surface area of 23 acres at a normal pool elevation approximately 7 feet below that of Hemlock Lake. The channel immediately downstream of the Lower Lake Dam is poorly defined, with swampy overbank areas. From about 500 yards downstream of Lower Lake to Blue Heron Lake, the stream is on a grade in excess of 4 percent. Blue Heron Lake Dam impounds a 90 acre reservoir. The dam is provided with two concrete spillways and a low level outlet. (See photo on page 6 of Appendix D). Approximately 50 houses are located along the shore line of Blue Heron Lake.

**DEVELOPMENT ALONG SHORE OF BLUE HERON LAKE
ABOUT 2 MILES DOWNSTREAM OF HEMLOCK LAKE DAM**

A formal warning system should be implemented because of the possibility of loss of life and significant property damage downstream in the event of a failure of the structure.

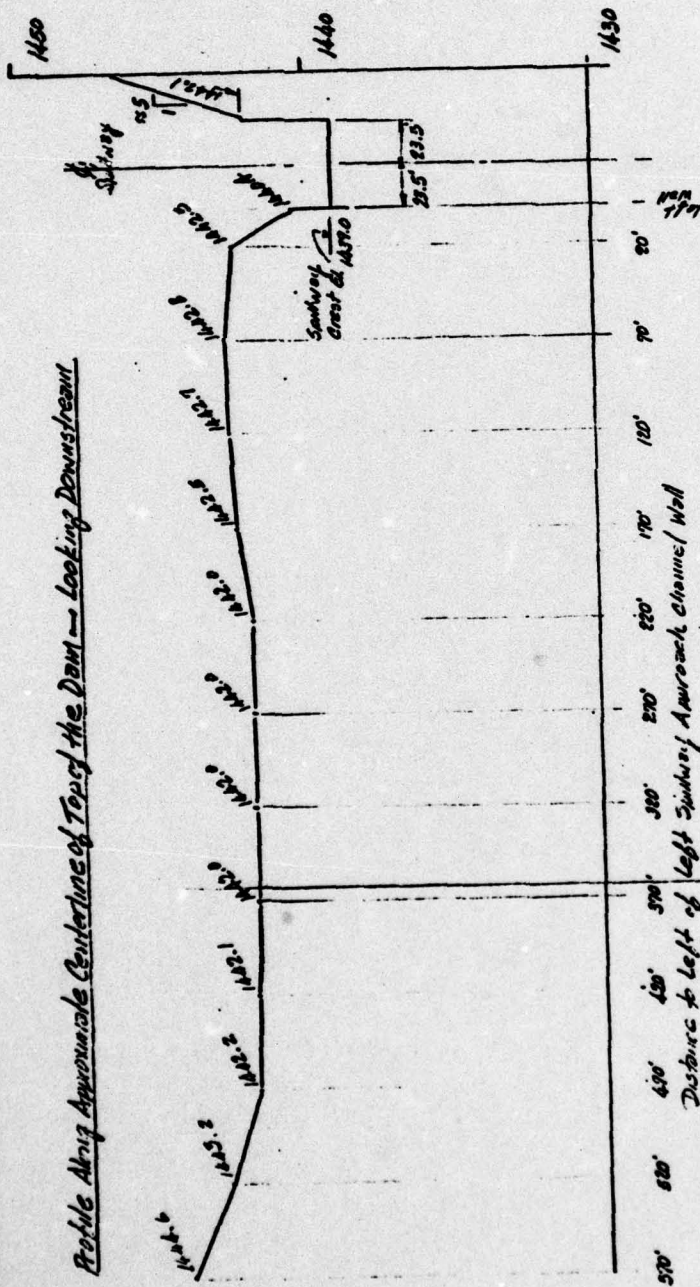
HEMLOCK LAKE DAM
PROFILE ALONG APPROX. CENTERLINE OF CREST OF DAM
FROM FIELD INSPECTION NOTES
FIELD INSPECTION DATE: NOV. 21, 1978
PLATE NO. 4

Profile Along Approximate Centerline of Top of the Dam -- Looking Downstream
